## **Wildlife/Dangerous Tree Assessment Report**

### **Tribune Bay Campground Expansion**

Assessments completed August 17, 2023

### **Wildlife Dangerous Tree Risk Assessment of Tribune Bay Campground Expansion**

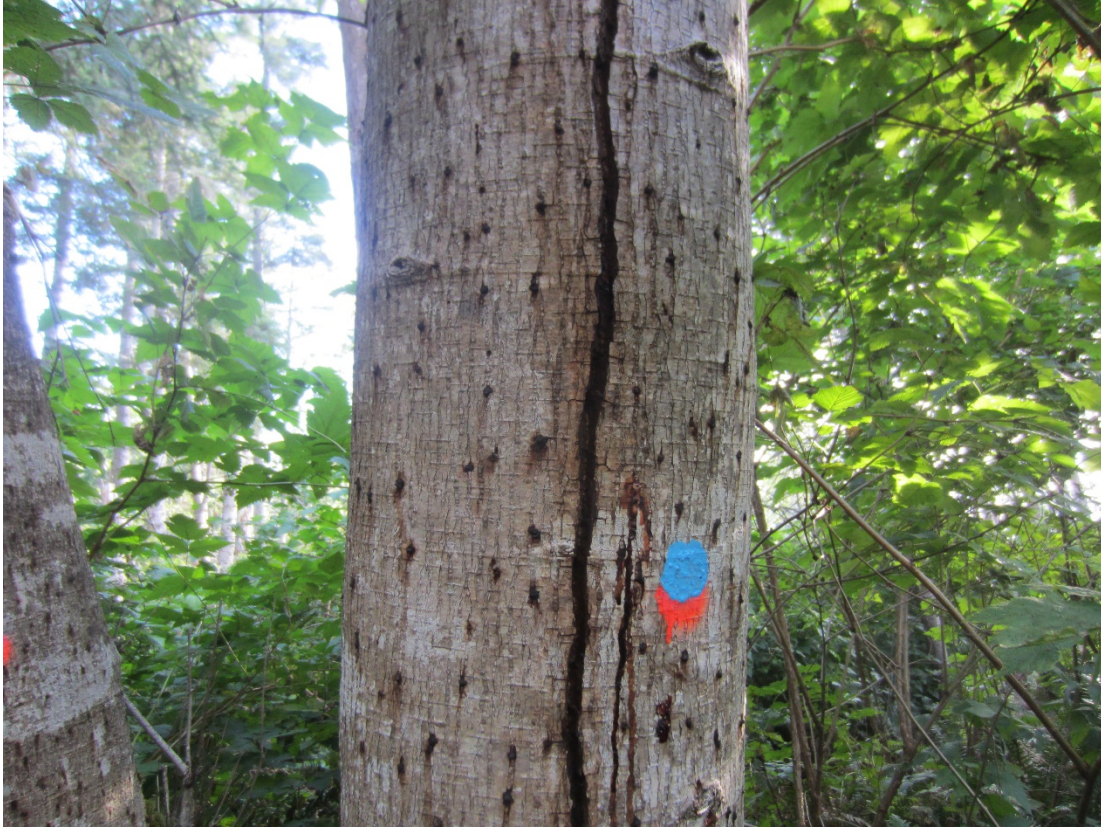
- Mature Dr trees are being attacked by alder bark beetle (*Alniphagus aspericollis*) and many show signs of a bleeding canker (*Phytophthora siskiyousensis*) and are dying consequently and failing soon after death. Several Dr stems have been damaged over their years and show advanced internal decay at these wound sites and have been collapsing or having mid-stem breakage. A few of the previously painted Dr trees failed since the previous assessment in January 2023, further supporting the need to remove the dead and dying Dr stems prior to developments.

**PHOTO 1:** View of a red alder tree with bark beetle attack; note the pitch holes from beetle attack. Such trees are likely to fail within 1-2 years of death because of accelerated stem decay.

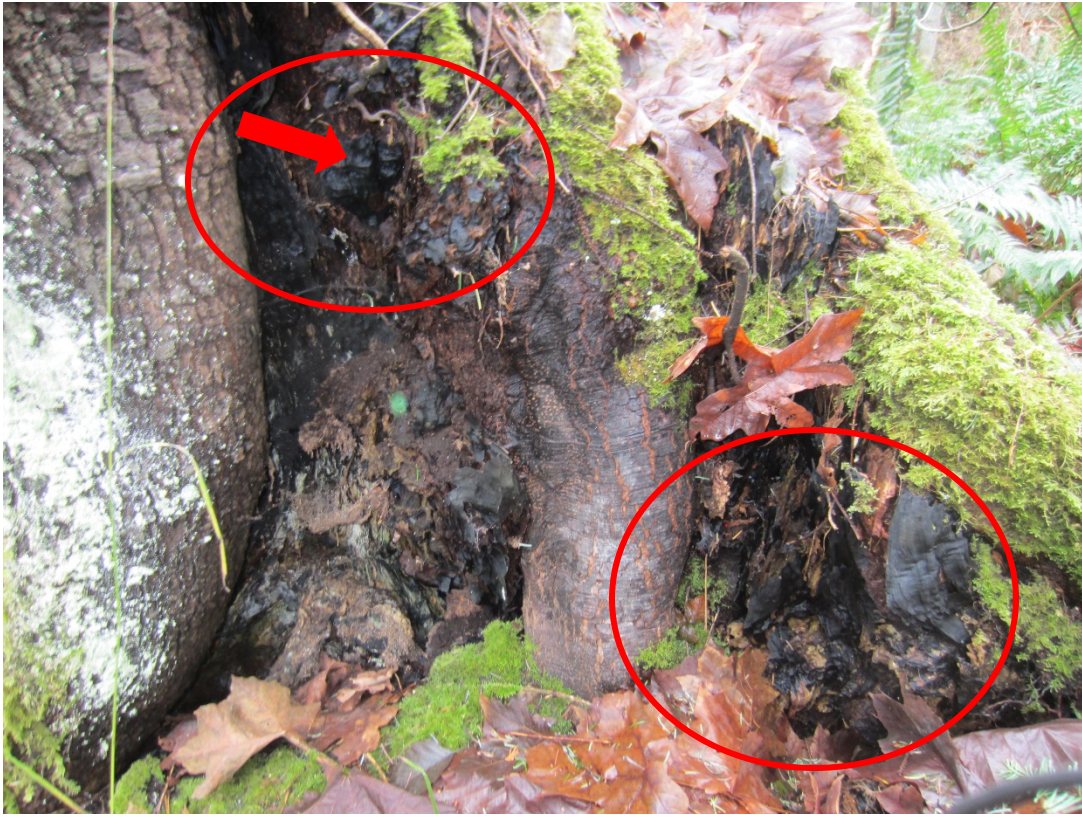
- Brittle cinder conk (*Kretzschmaria deusta*) was found on large, mature Mb trees that are in advanced stages of decline and/or had failure of twinned stems.

**PHOTO 2:** View of brittle cinder conk (*Kretzschmaria deusta*) on a bigleaf maple with basal damage. This is a dangerous tree and full tree removal is recommended. Cut with a high stump to remove the hazard while promoting coppice shoots for visual screening.

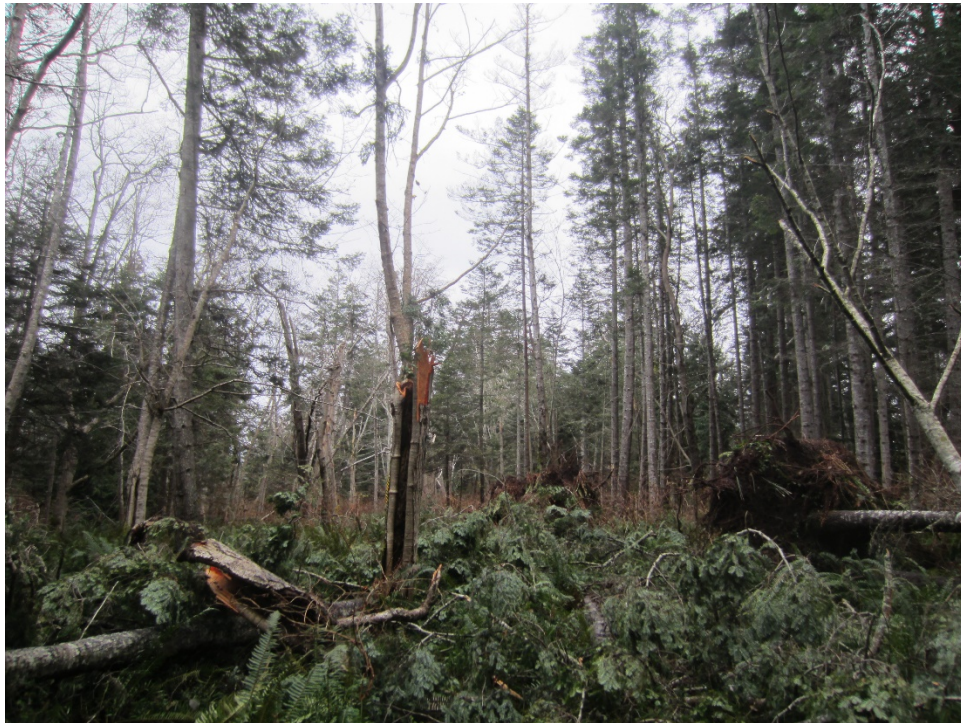
**PHOTO 3:** View of the stand conditions where wind is an important site factor leading to the marking of stem defective and wind prone trees for mitigation treatments.

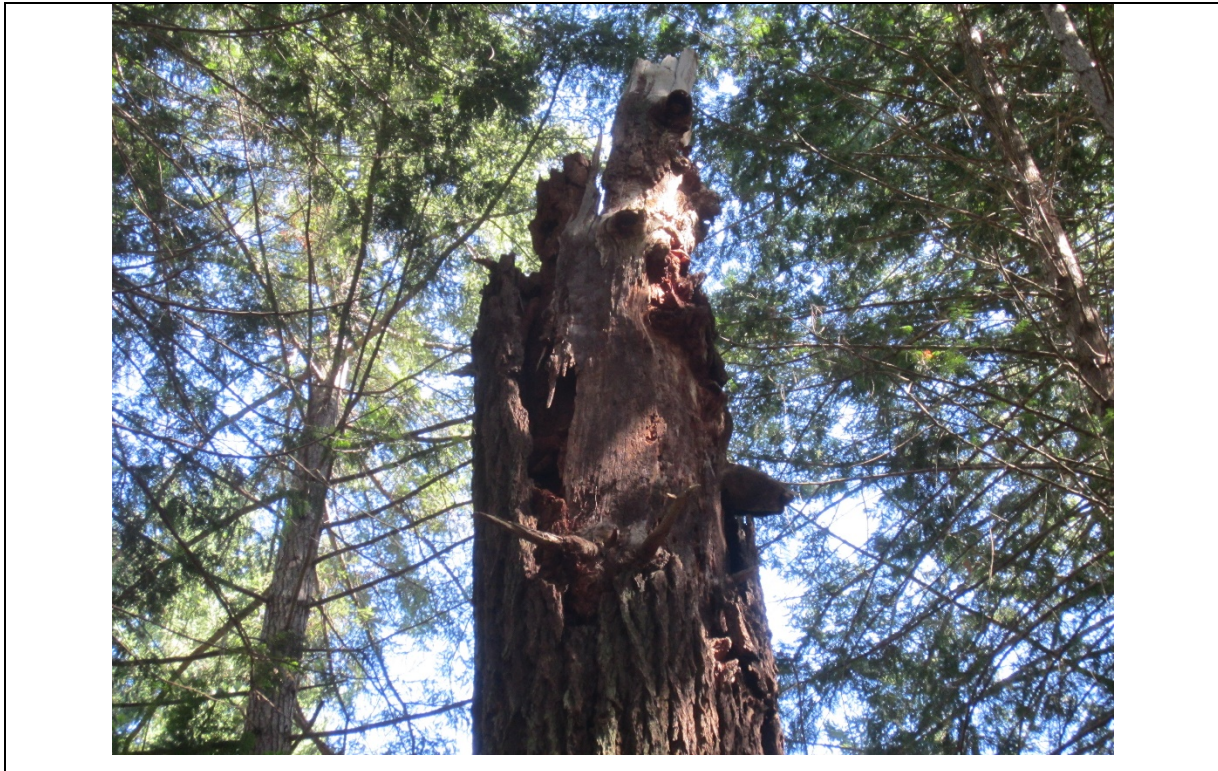
**PHOTO 4:** View of a remnant Fd class 7 tree with a highly unstable top. This tree is marked for removal because it is unsafe to climb for reduction treatments.

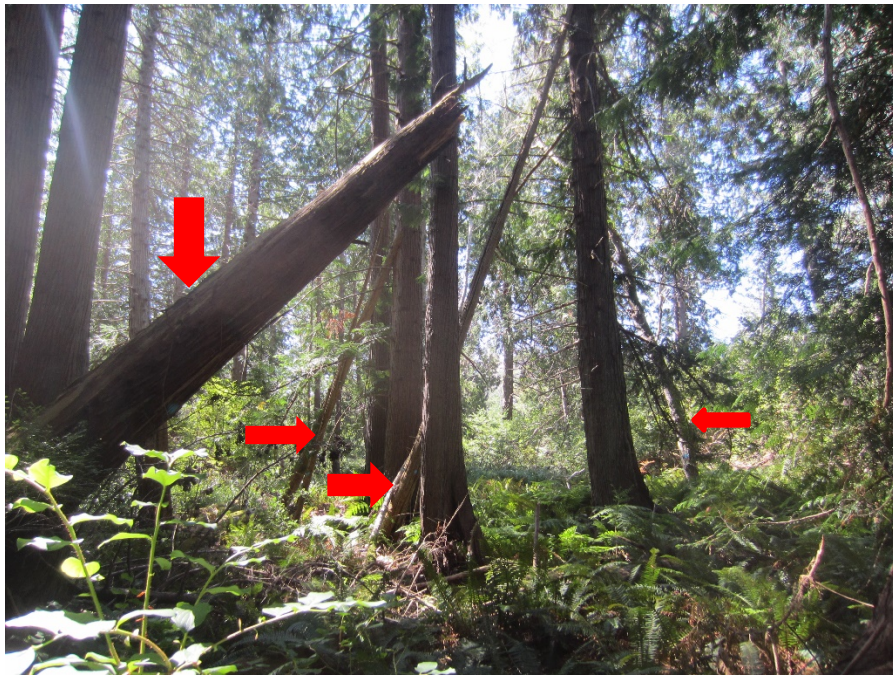
**PHOTO 5:** View of several tipped Cw trees which have been marked (blue dots) which are hazards to campground development and are thus recommended for removal.

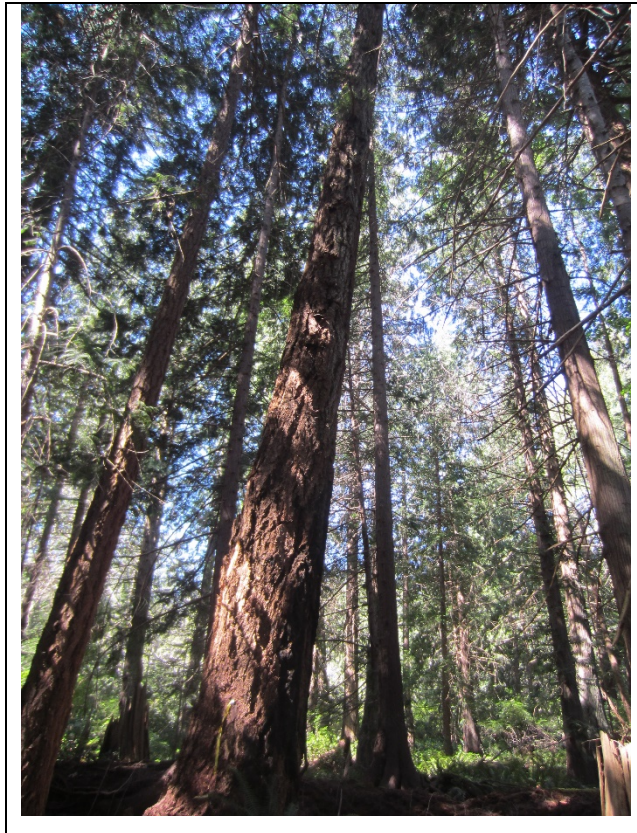
**PHOTO 6:** View of Fd veteran #334 that has infection by *Phaeolus schweinitzii* and *Porodaedalea pini*. Therefore, it poses a risk to the planned developments and to the public road and hydro lines. Reducing the tree to a 15m stub is recommended to eliminate the hazards and retain the tree for wildlife habitat.

| Park or Rec Site: Tribune Bay | | | | | | | | | | | | | | | | | | | | Location: Hornby Island | | | | | | | | | | Assessor's Name:<br>Dean McGeough | | | | Date: Aug. 17, 2023 | | | |
|---|---|---|---|---|---|---|---|---|---|---|---|---|---|---|---|---|---|---|---|---|---|---|---|---|---|---|---|---|---|---|---|---|---|---|--|--|--|
| 1107 - multiple dead tops - reduce to 20m; 750 - weak seam at candelabra, reduce by 15m; 334 - Butt rot + P. pini - reduce to 15m; 335 - saprot CM and can reach road | | | | | | | | | | | | | | | | | | | | | | | | | | | | | | | | | | | | | |

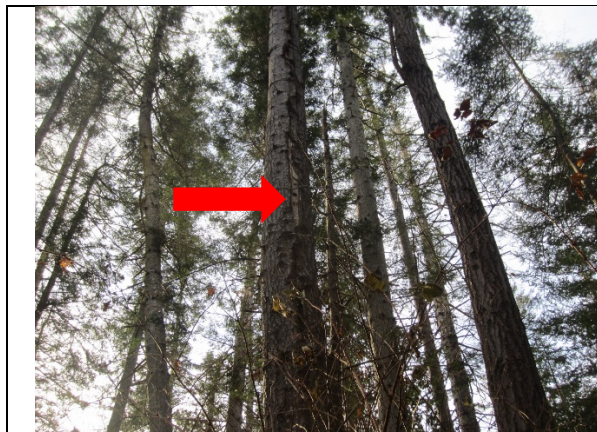
**PHOTO 9:** Bg tree #110 has a pronounced stem scar. This live tree has a cavity nest (red arrow) and topping above the nest is recommended.

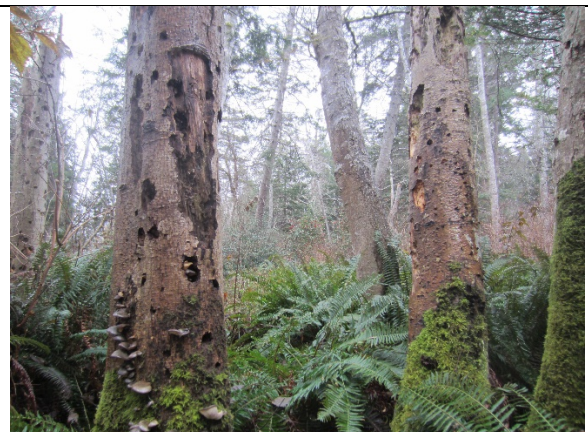
**PHOTO 10:** Examples of highly decayed Alder stems recommended for removal.

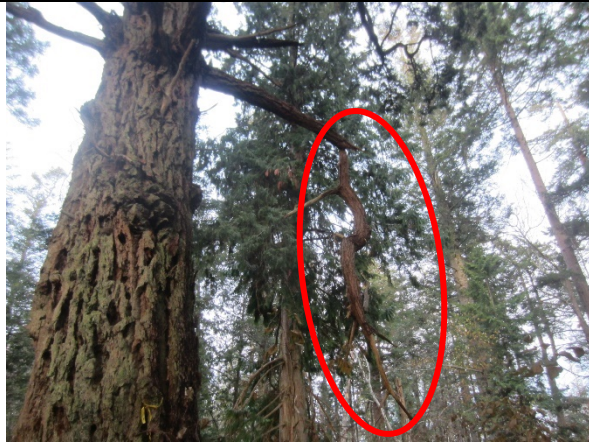
**PHOTO 11:** View of Fd veteran tree #114 with a large hanging limb – NWZ was flagged out until tree can be treated.

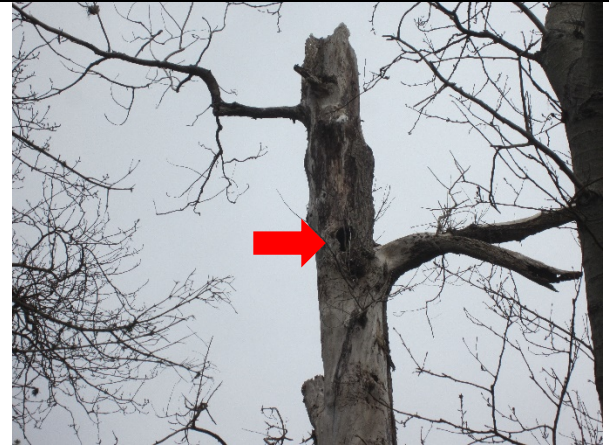
**PHOTO 12:** Cottonwood #134 has a large natural cavity dwelling (red arrow). Retention is possible if this area is excluded from development.

| DANGER TREE ASSESSMENT FIELD DATA – PARKS | | | | | | | | | | | | | | | | | | | | Assessor's Name:<br>Dean McGeough | | | | Date: Dec. 14-16, 2022;<br>5, 2023 | | | | Jan. 3- | | | | |
|---|---|---|---|---|---|---|---|---|---|---|---|---|---|---|---|---|---|---|---|---|---|---|---|---|---|---|---|---|---|---|---|---|
| 133 (beside #132), remove dead top (12m); 134 - No hazard exposure to beach, avoid developments; 135 - CN at 4m, reduce to 10-15m; 136 - on nurse stump | | | | | | | | | | | | | | | | | | | | | | | | | | | | | | | | |
